# Unexpected— Earthquake 2011

Lessons to Be Learned

*Edited by  
A. Elena Charola,  
Corine Wegener,  
and Robert J. Koestler*

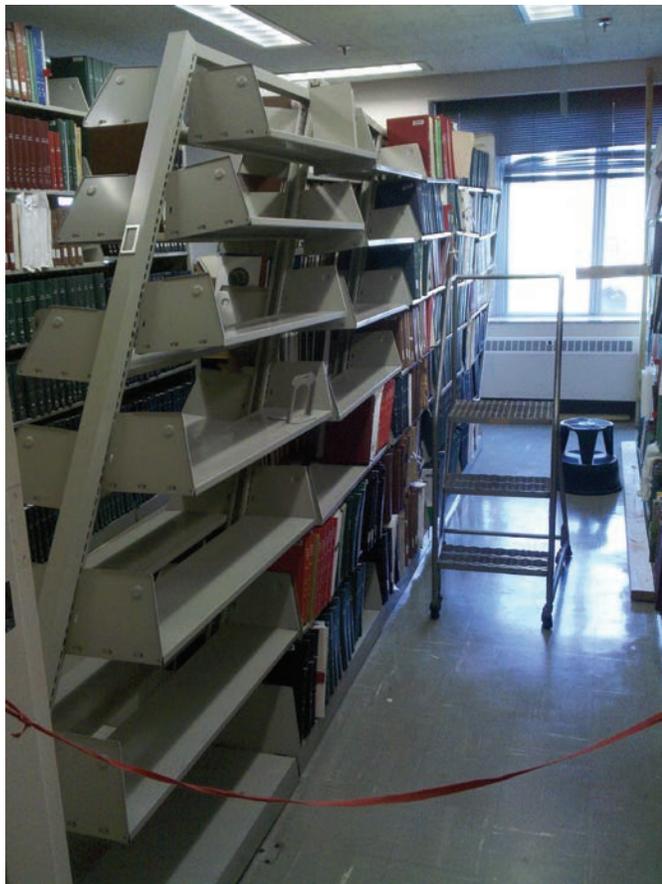
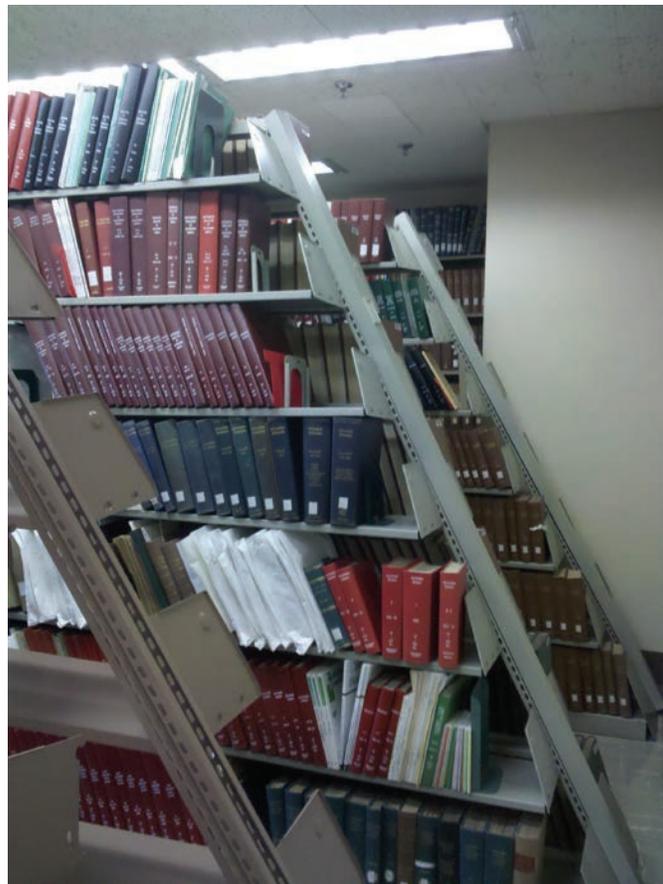
FIGURE 2. Images of twisted and distorted shelving kept in place by the weight of the books. (Smithsonian Institution photos by M. Kalfatovic; see more at <http://www.flickr.com/photos/travelinglibrarian/sets/72157627394103839/with/6077290443/>.)

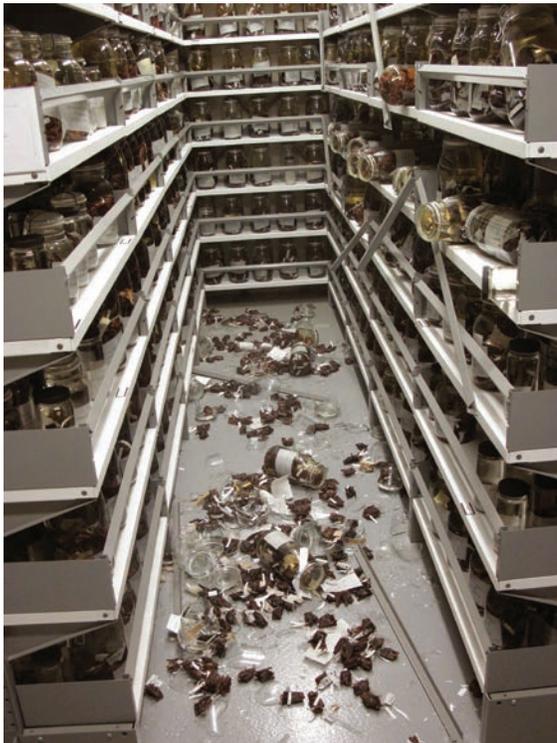
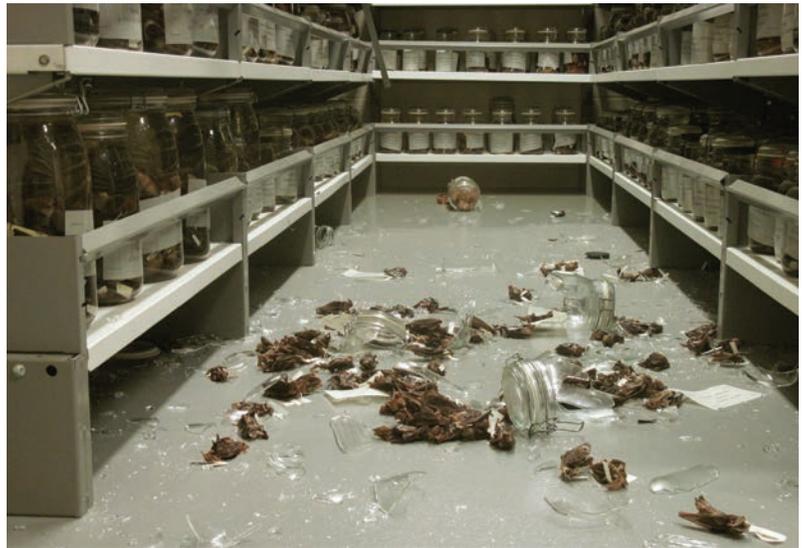
FIGURE 1. Two views of some of the central aisles of the Division of Mammals' fluid storage bunkers. Above, bat specimens that had been in the bottles are lying on the floor among the glass shards. (Photos by Suzanne C. Peurach, USGS Patuxent Wildlife Research Center.)

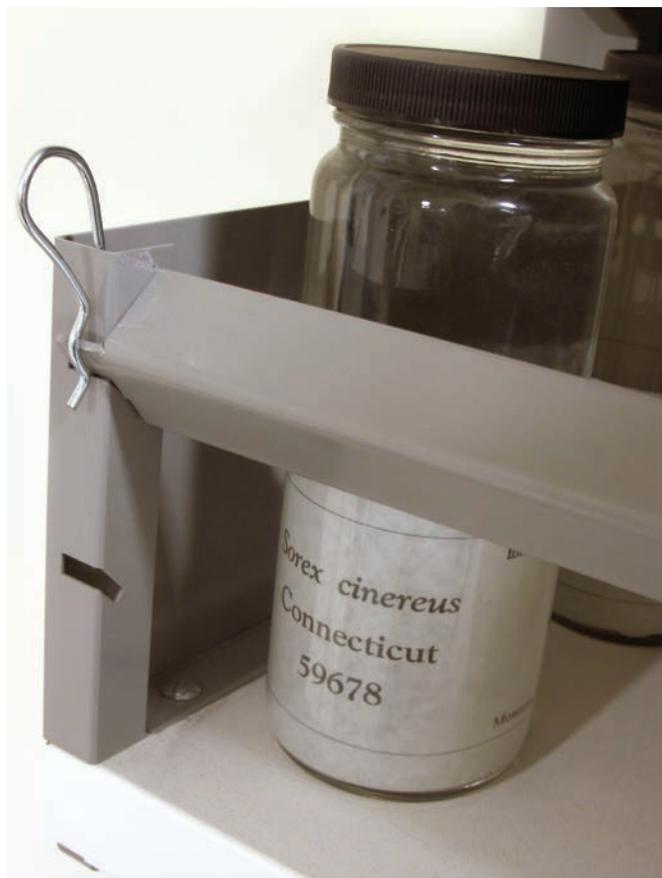
FIGURE 4. Earthquake bars were originally designed to slide into slats on each side of every shelf. Hairpin cotter pins were applied to fasten the bars into place and prevent future failure. (Photos by Suzanne C. Peurach, USGS Patuxent Wildlife Research Center.)

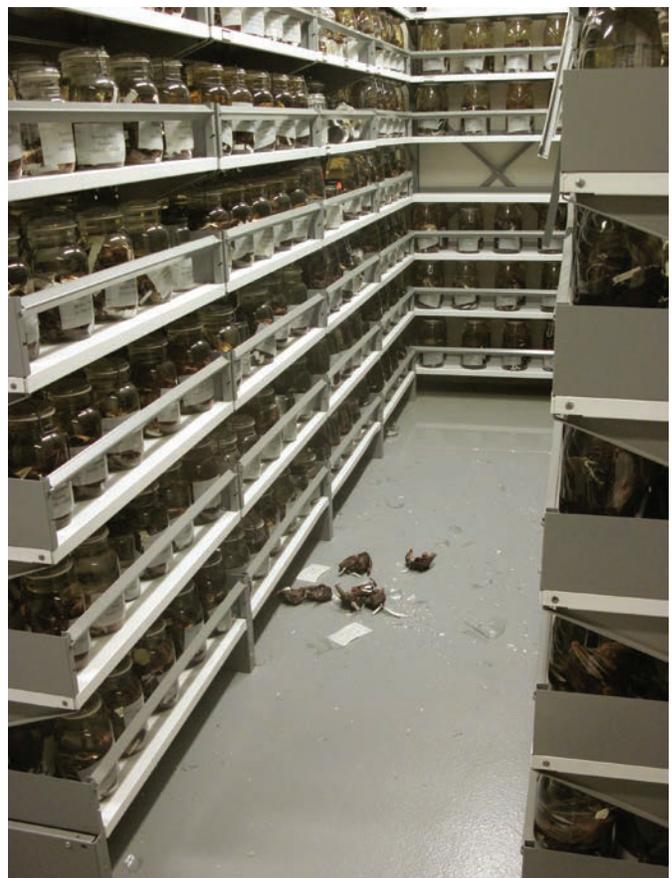
FIGURE 5. Jars on perimeter shelving had much less damage than those located in the central aisles of each alcohol storage bunker. (Photos by Suzanne C. Peurach, USGS Patuxent Wildlife Research Center.)

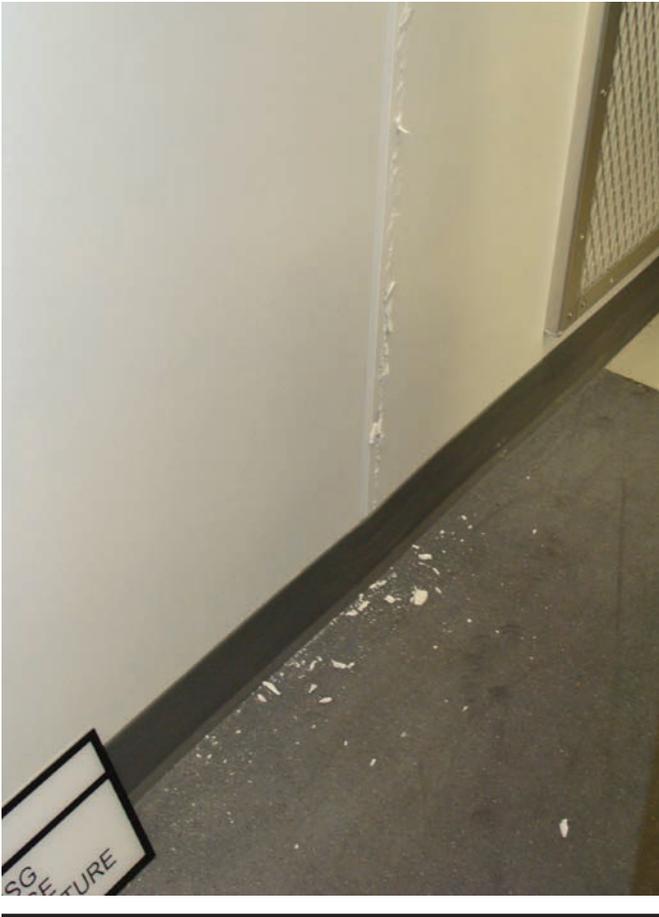
FIGURE 1. Cracks in the wall of Pod 3 at the MSC. (Smithsonian Institution staff photo.)

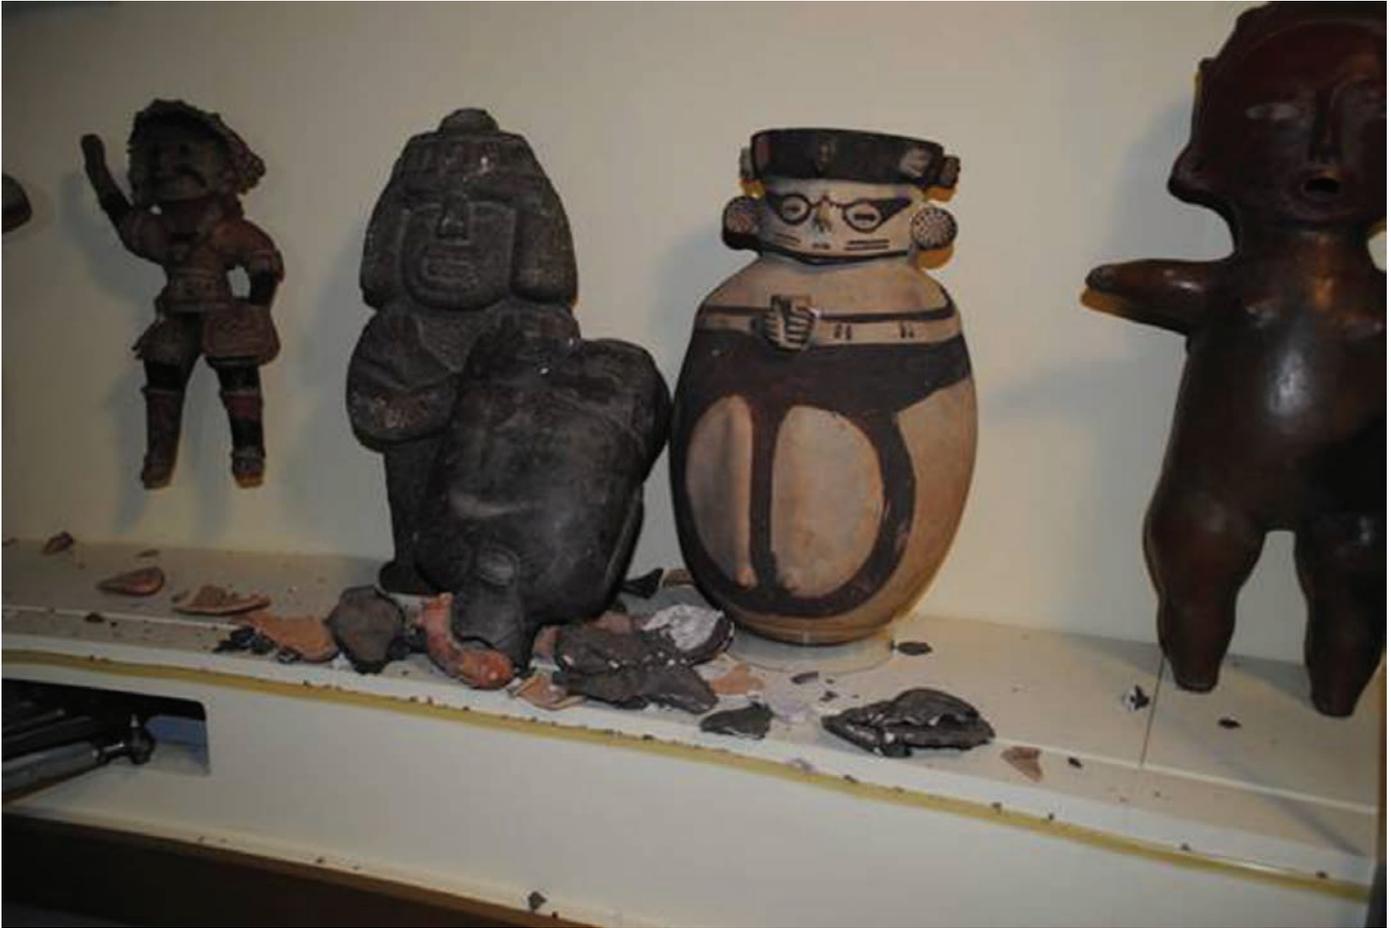
FIGURE 1. Falling ceramic objects caused abrasion and chips to a Mexican stone figure and a Peruvian ceramic pitcher. (Smithsonian Institution photo by Gail Joice, NMAI.)

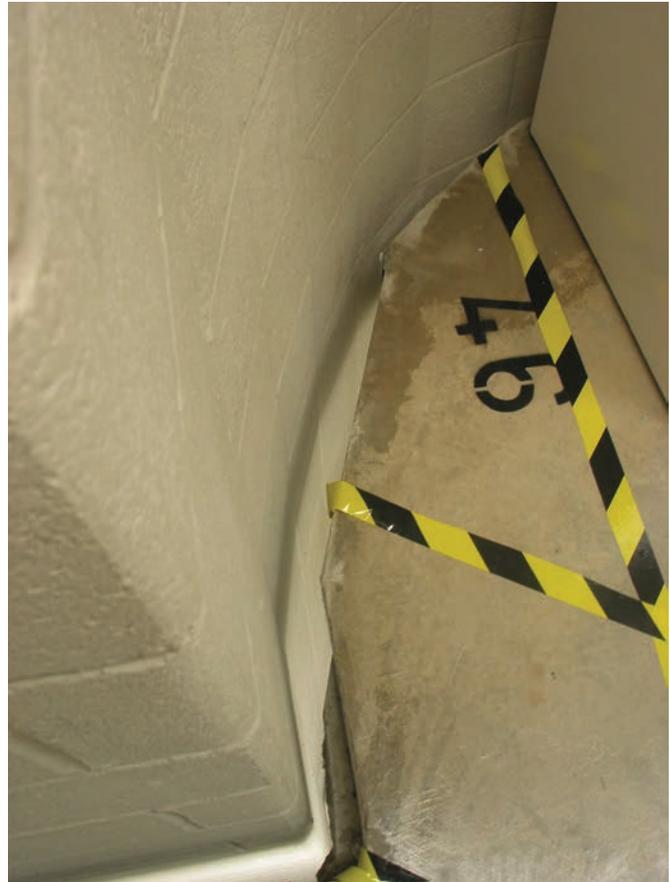
FIGURE 1. Space between wall and floor of Pod 1. (Smithsonian Institution photo by David Rosenthal, National Museum of Natural History, Department of Anthropology.)

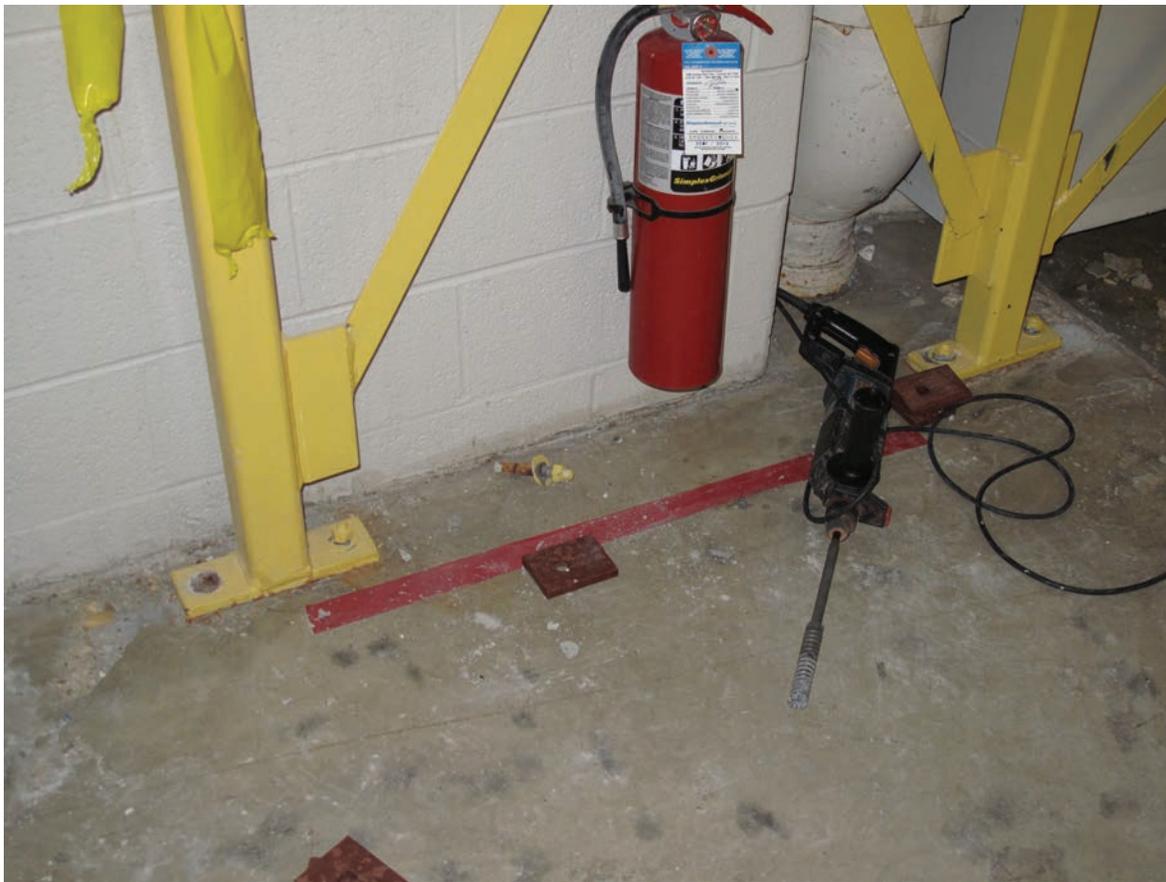
FIGURE 2. Bolts sheared off or torn from Pod 1 floor. (Smithsonian Institution photo by David Rosenthal.)

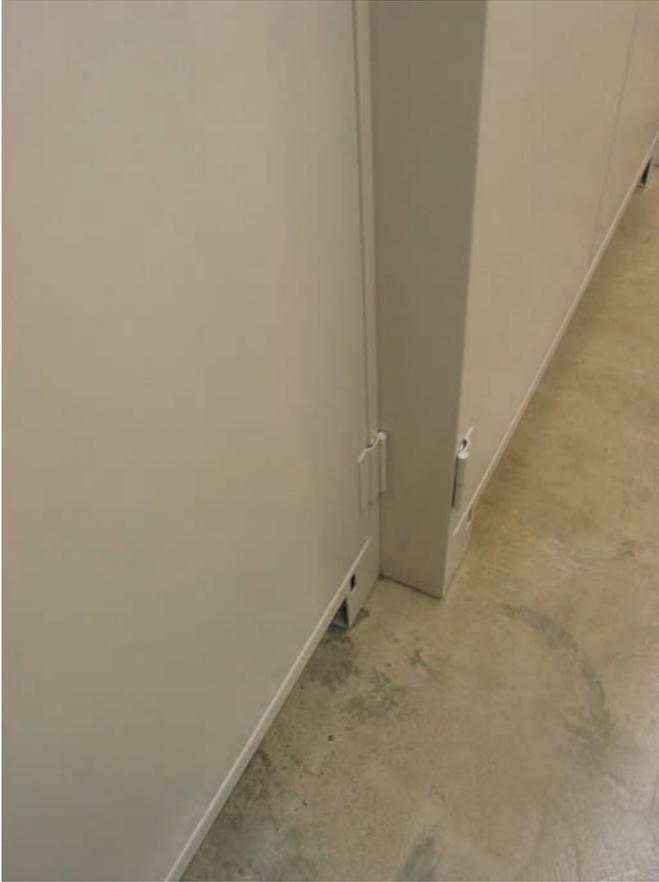
FIGURE 3. Shifting of shelf cabinets, Pod 1, level three. (Smithsonian Institution photo by David Rosenthal.)

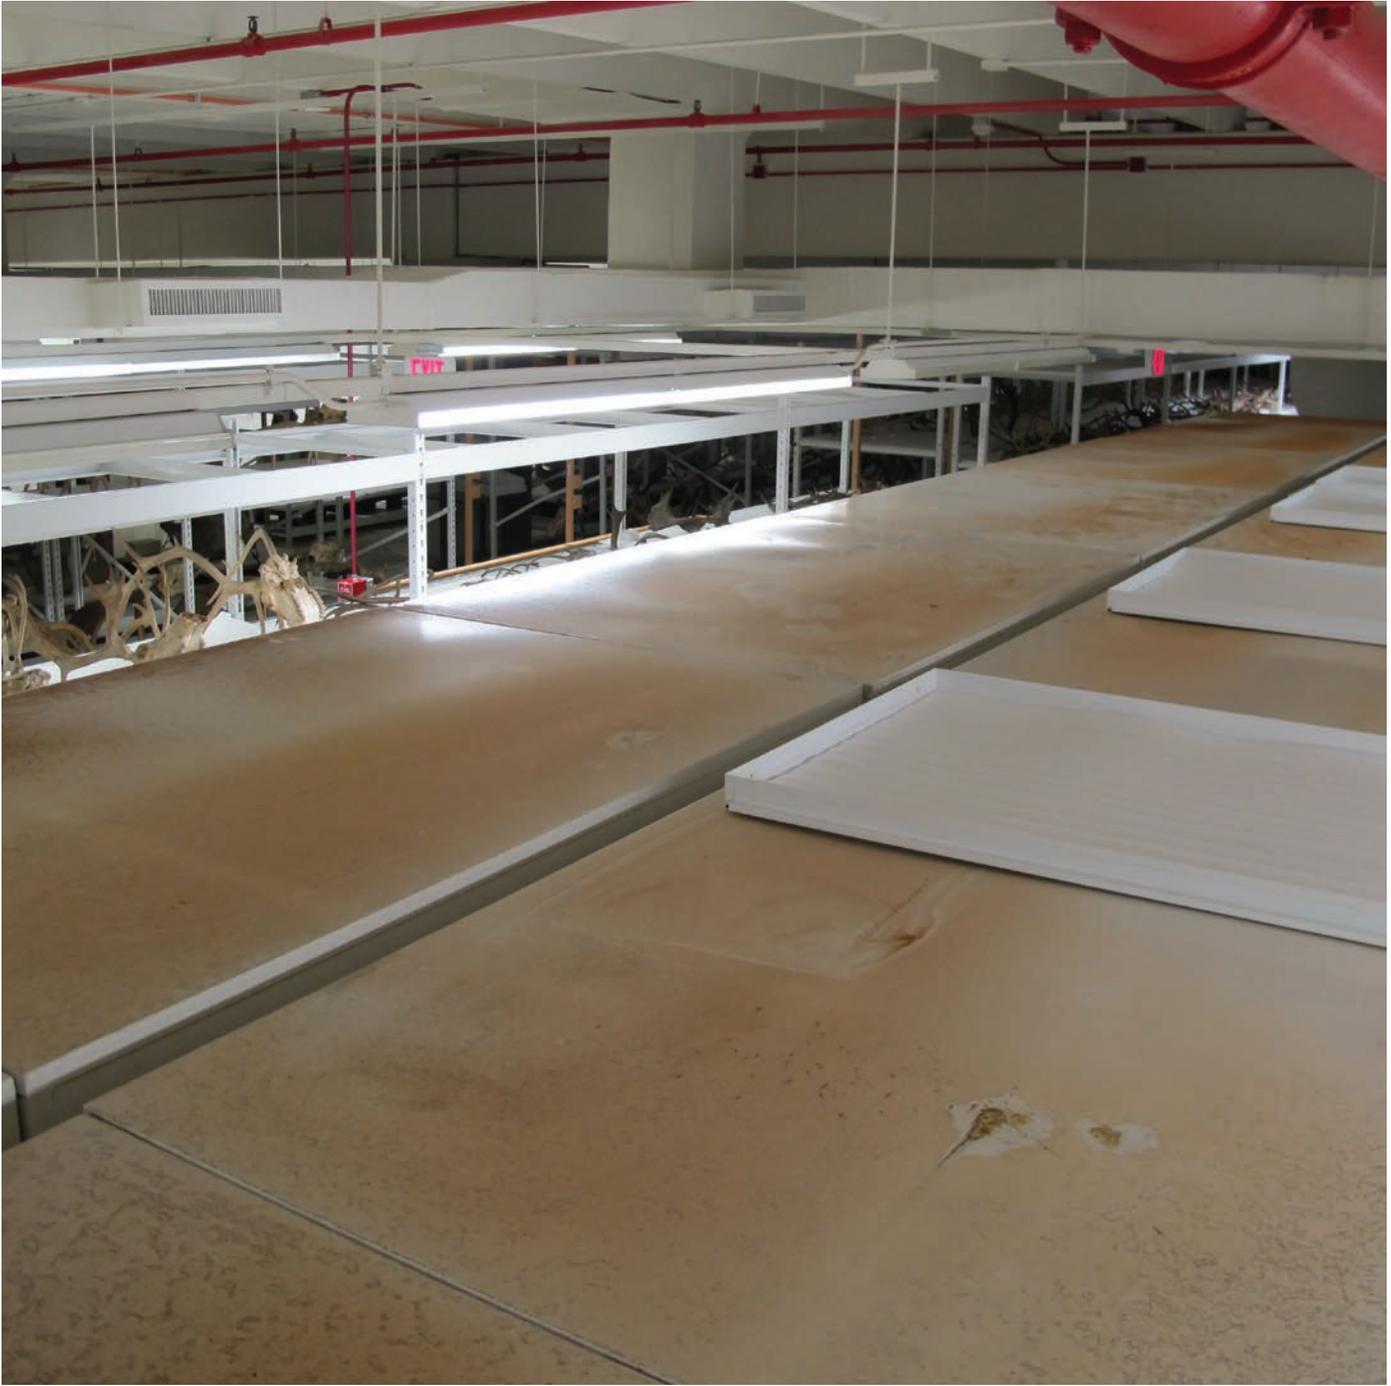
FIGURE 2. Rusty-colored water on case tops in Pod 2. (Smithsonian Institution photo by Catharine Hawks, NMNH.)

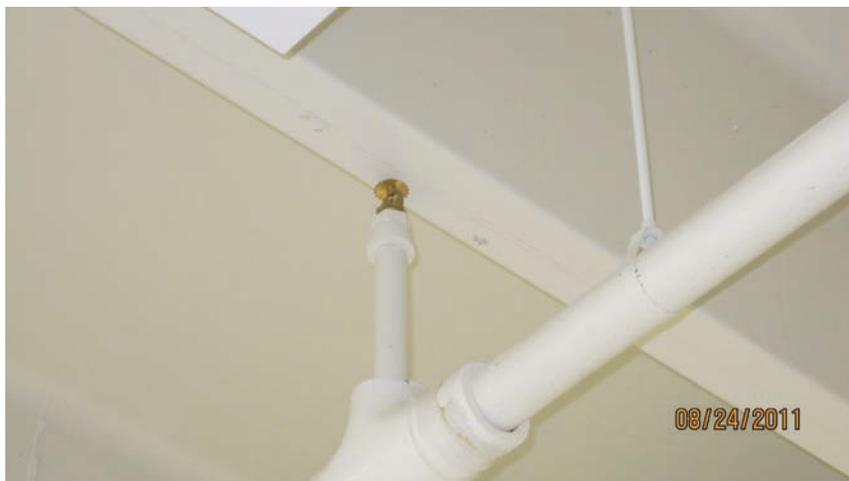
**FIGURE 3.** Above, sprinkler head as installed; right, sprinkler head in Pod 3 sheared off during the earthquake. (Smithsonian Institution photo by Catharine Hawks, NMNH.)

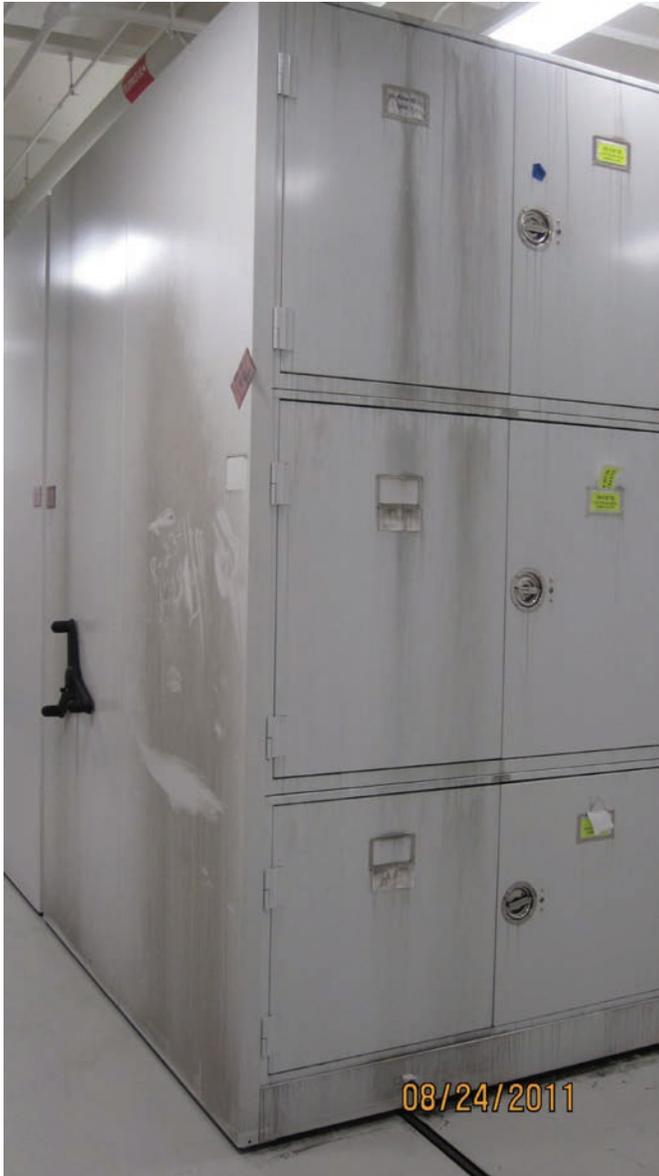
**FIGURE 4.** Cabinets stained by the blackish water released from the broken sprinkler heads in Pod 3. (Smithsonian Institution photo by Catharine Hawks, NMNH.)

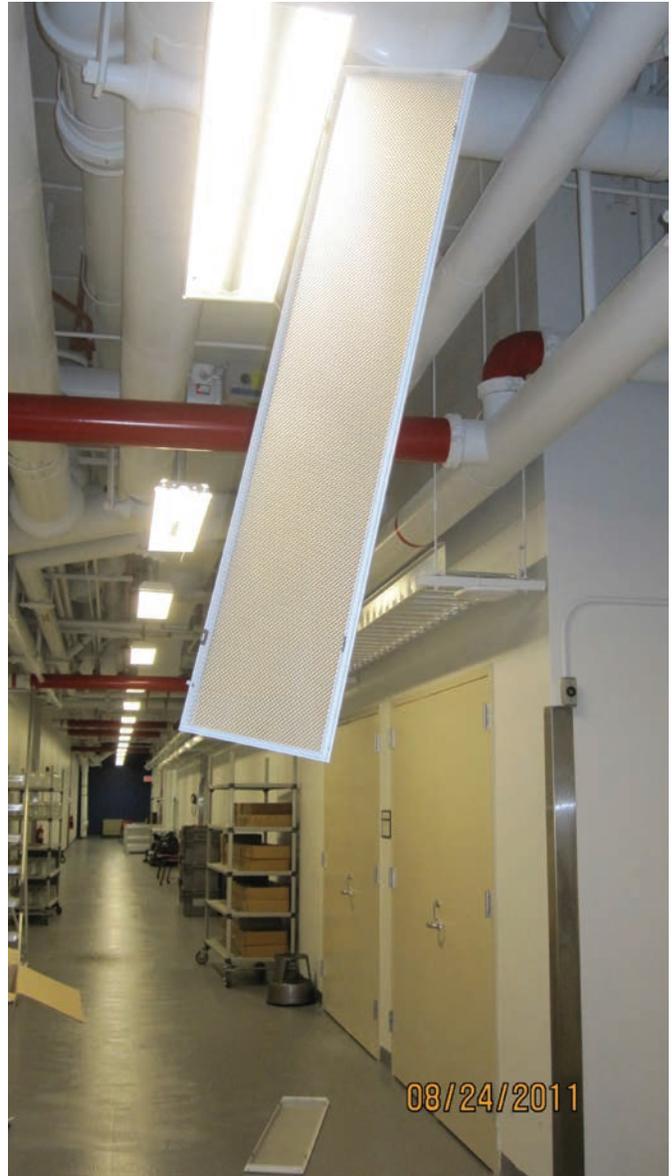
**FIGURE 5.** Minor, superficial damage in Pod 5. (Smithsonian Institution photo by Catharine Hawks, NMNH.)

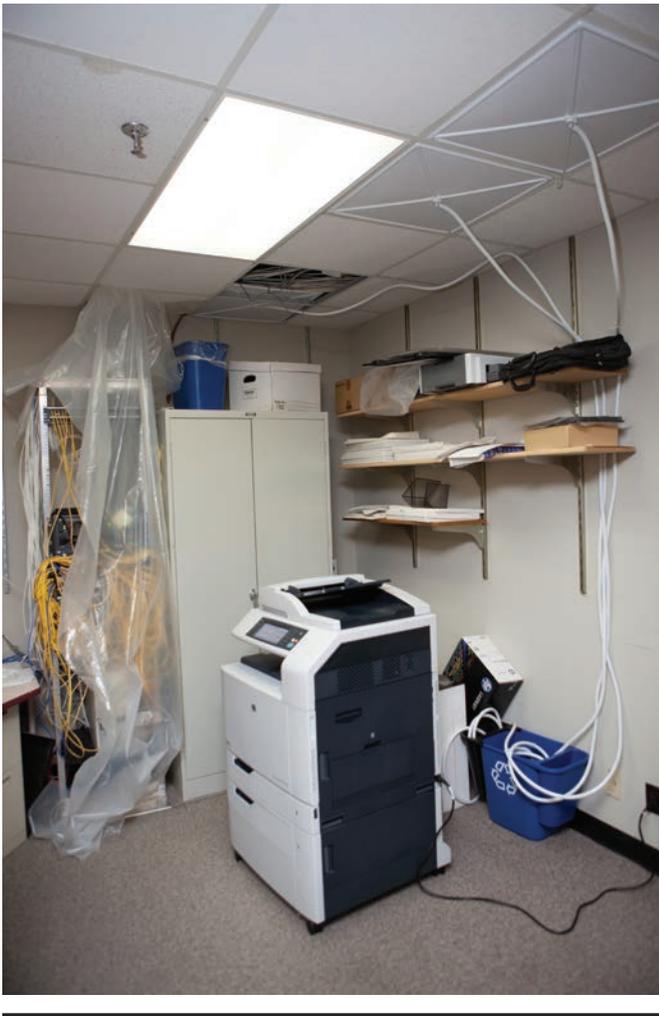
**FIGURE 6.** One of the most persistent leaks in the Museum Conservation Institute, still unresolved when photo was taken in January 2013. (Smithsonian Institution photo by E. Keats Webb, MCI.)

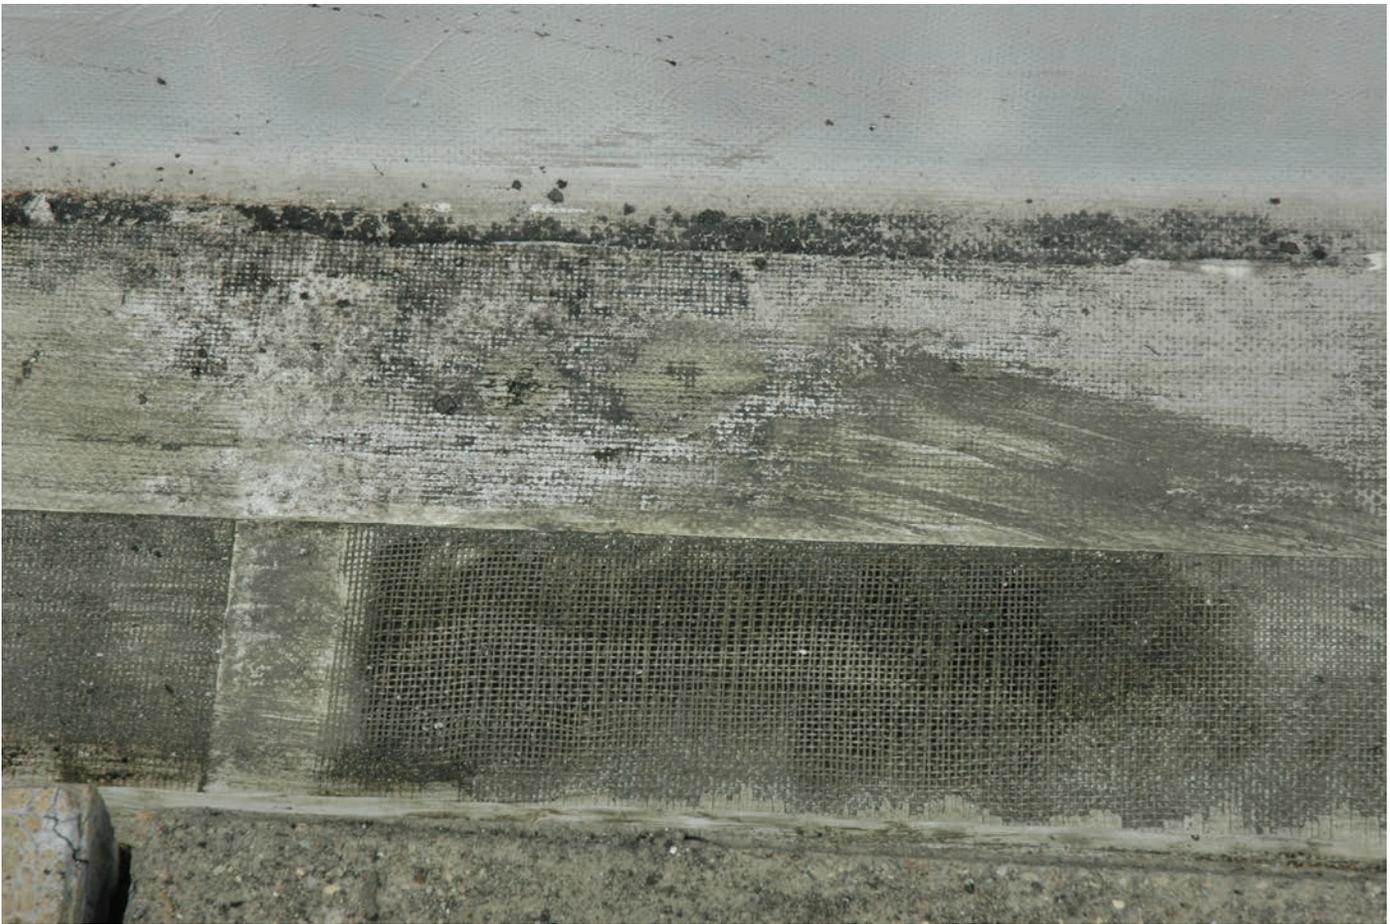
FIGURE 7. Detail of the eroded membrane leaving the woven support exposed. (Smithsonian Institution photo by Carol A. Grissom, MCI.)

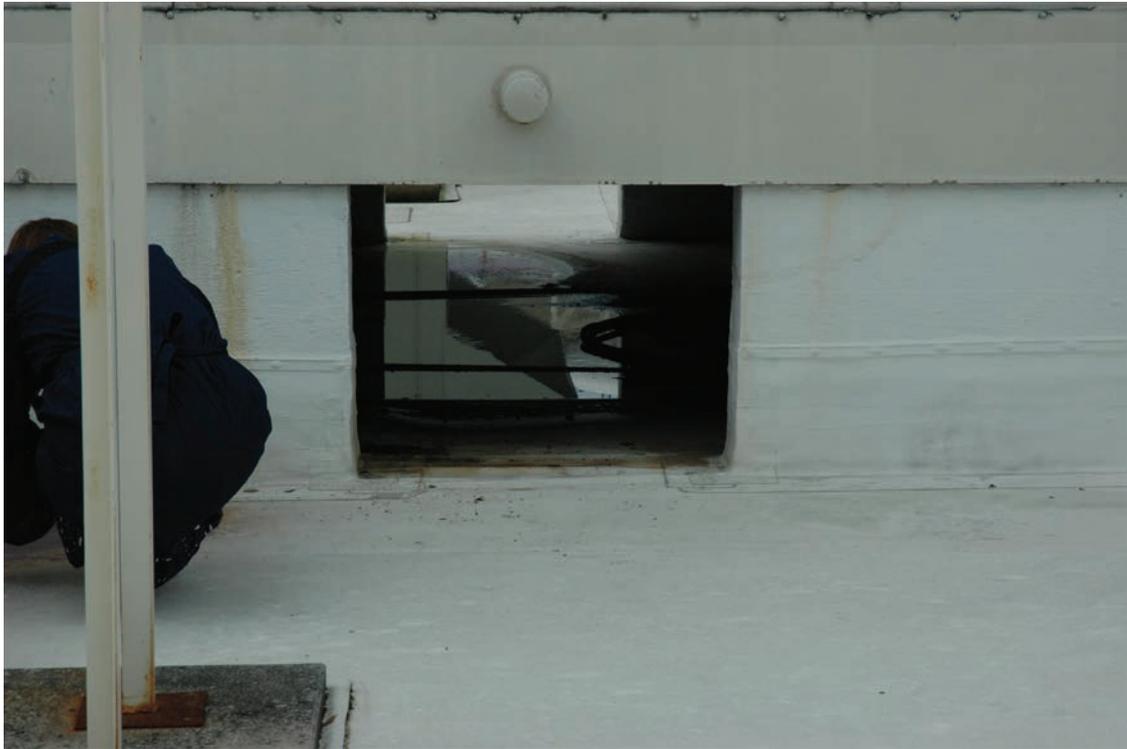
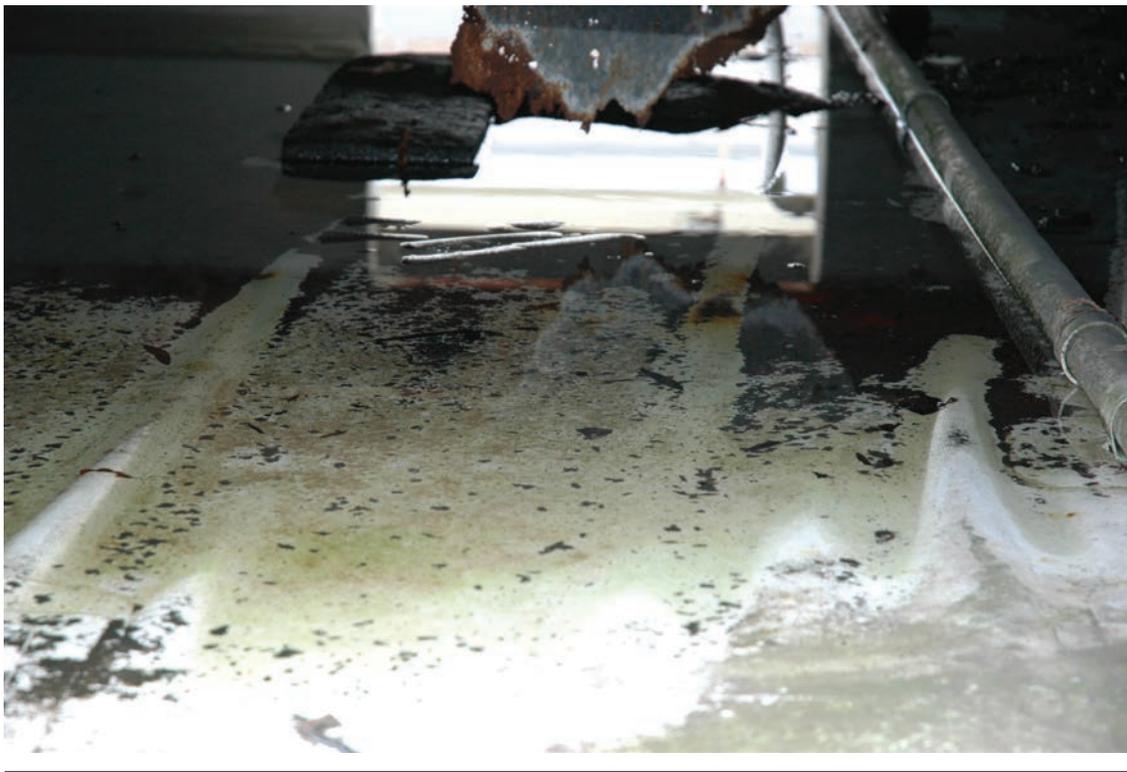
FIGURE 8. Top, large pool of standing water under air handling unit; bottom, detail of standing water with algae and gray-colored deteriorated roof membrane. A hanging piece of the corroded metal underpan is visible at the top center of the image. (Smithsonian Institution photo by Carol A. Grissom, MCI).
